BRAVA
HUGHENDEN VALLEY DRAINAGE IMPROVEMENT GROUP
FLOOD RISK AREAS

1. Hughenden Valley Risks Map

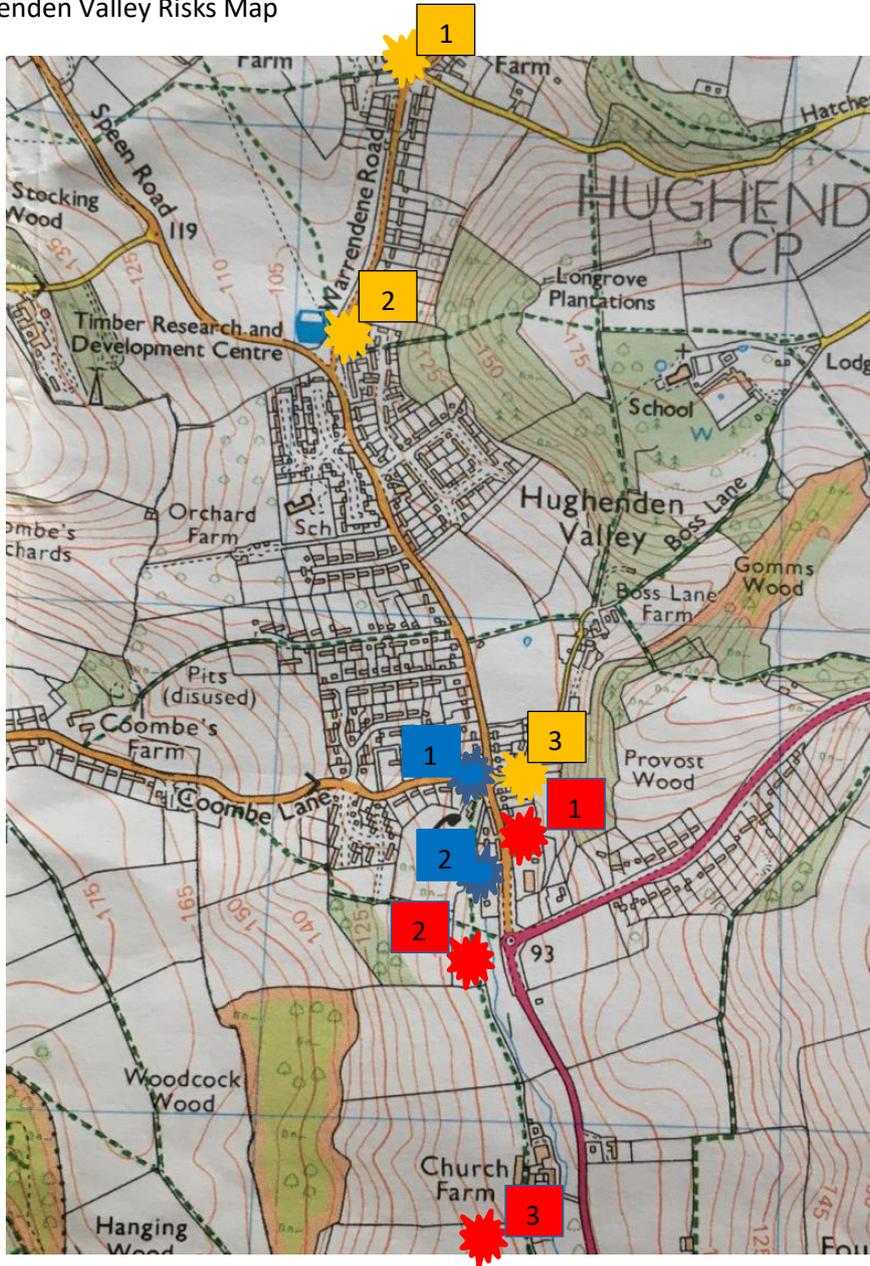
The map identifies the areas HVDIG consider to be the most at risk based upon our experiences going back many years, but particularly since 2000.

Risk No 1 is at the top of Warrendene Road at the junction with Hatches Lane. This is where the stream rises and can spill onto the road. The drainage ditch along the left of Warrendene only starts 100-200 metres further along from the junction.

Risk No 2 is at the bottom end of Warrendene Road close to the junction with Valley Road. At this point the ditch on the left hand side of Warrendene enters a culvert, crosses the road and then continues under the road down Valley Road. Where the culvert starts is notorious for flooding the road and threatening the pub opposite. The Harrow pub was flooded in 2014.

Risk No 3 is in the corner of Boss Lane on the bend where the field gate is situated. There are several issues concerning this area. These are:

Risk No 1 is an elongated area stretching from Boss Lane south as far as the Hughenden Surgery and encompasses all 11 houses along this stretch plus the industrial estate and the Surgery. Predominantly, it is only the properties on the east side of Valley Road that are affected, but escapes have also occurred across the road in Spring Rising. As indicated earlier, this point is the lowest in the valley; in both 2000 and 2014 sewage escapes have occurred from household inspection pits as well as from the sewer manholes which run along the pavement.

Risk No 2 is an area in the field immediately to the south of the Affinity pumping station. It is understood to be the junction of the Hughenden main sewer with the one coming down from Naphill. It overflows from time to time due to blockages or overloading and allows sewage to escape directly into the Hughenden Stream.

Risk No 1 is on Valley Road at the foot of Coombe Lane and is also at a low point in the valley so that water also flows strongly to this area from further up Valley Road. Recent road drains, gully & chambering work plus road surfacing have vastly improved the road drainage of this area. The road is now performing well with one exception.

Risk No 2 relates to the ditch running along the west side of Valley Road, which has been cleaned out during the recent works. With the road drainage system working well, this ditch can fill remarkably quickly. At its southern end it empties into a culvert running under the pumping station property. The ditch empties slowly through this single pipe and hence the ditch carries the risk of overflowing on to Valley Road.
